# Manhole Inspection Summary

Manhole # S15MM1024MH

Insp Date: **4/6/07 10:18 AM**

**Location** Address: **4701 GREENSPRING AVE**

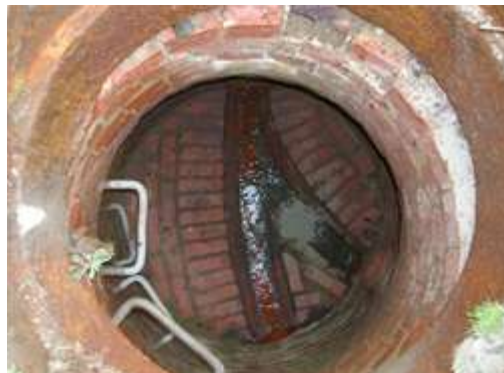
Top View

Channel debris.

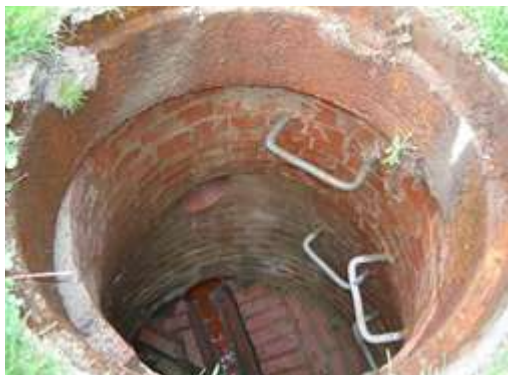
Defect

Frame leaks. Adjustment loose brick, deterioration and infiltration. Corbel and Barrel infiltration - other side.

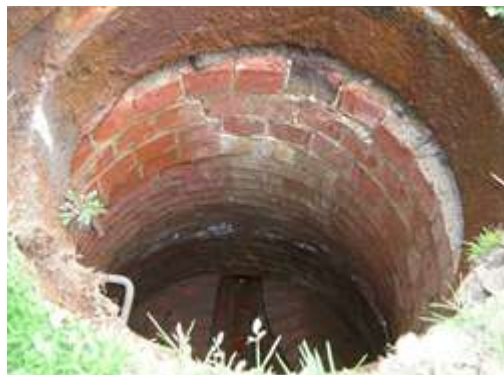
Defect

Frame leaks. Adjustment loose brick, deterioration, cracks and infiltration. Corbel and Barrel infiltration.

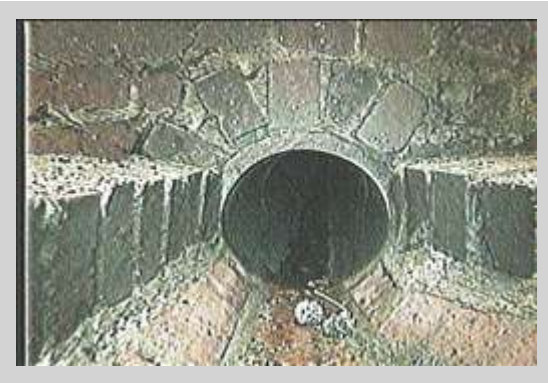
### 8 in. Circular Gravity Sewer Pipe Out @ 12 O'Clock

Barrel deterioration and infiltration. Channel deterioration.

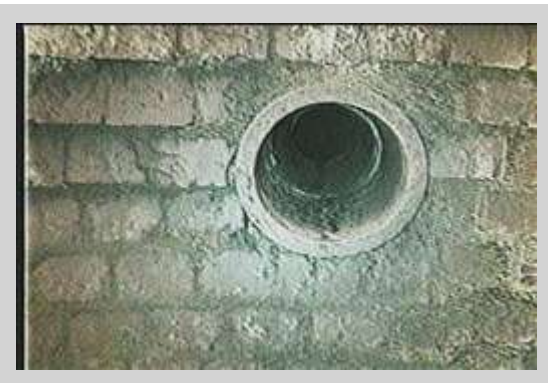
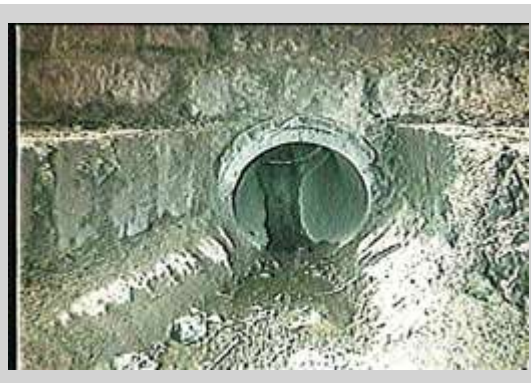
### 6 in. Circular Gravity Sewer Pipe In @ 4 O'Clock

Barrel deterioration and infiltration. Channel deterioration.
